TALKING POINTS

Flame-Plated Impellers

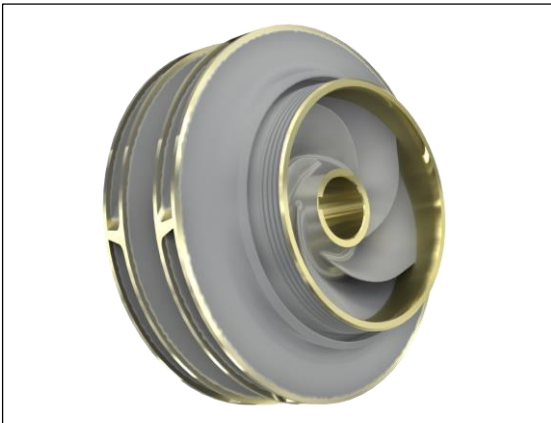
The flame plating process consists of adding tungsten carbide to the surfaces to be protected from wear. This unique process produces extremely hard, well-bonded, wear-resistant coatings which consistently outwear hard chrome plating, tool steel and solid tungsten carbide.

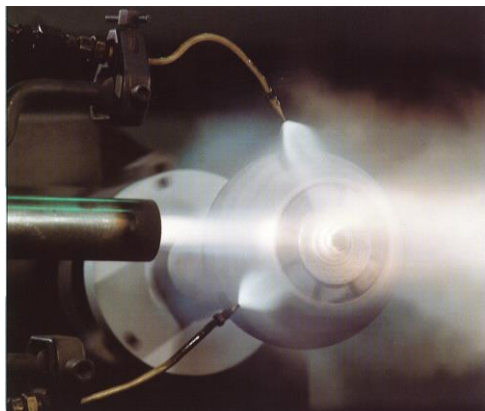
A specially constructed gun is used to blast tiny particles of tungsten carbide onto and into the base metal. This gun resembles a large-caliber machine gun. When measured quantities of oxygen, acetylene and particles of coating material are metered into the firing chamber, a timed spark detonates the mixture. This creates a hot, high-speed gas stream which instantly heats the particles to a plastic state and hurls them at supersonic velocity (2500 fps) from the gun barrel. The near molten particles impinge onto the surface of the work piece where a microscopic welding action produces a tenacious bond. Rapid-fire detonations, during automatically controlled passes across the work piece, build up the coating to a specified thickness.

Although temperatures above 6,000°F are reached inside the gun, the work piece remains below 300°F. Thus, metallurgical properties of the base material are not changed during the coating process. Low temperatures in the substrate also eliminate the possibility of warpage, distortion or other physical change in precision parts. The impeller hub surface, when flame plated, is approximately twice the hardness of the hardest tool steel. An attempt to score the surface with a good metal file would prove harmful to the file, not the flame plated hub. This feature may be specified as follows - The impeller hubs to be flame plated with tungsten carbide to assure longer pump life and lower maintenance costs.

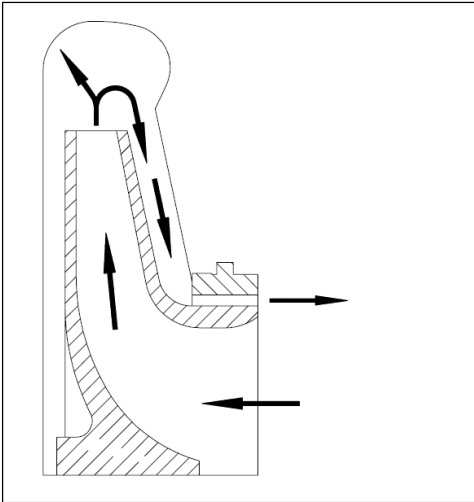
Plain Wear Rings

With ordinary wear rings the path is short and straight, so the friction loss is low and the leakage rate high. There are two ways to add to the length and to make the path crooked, one is called the “wrap-around” wear ring and the other is the “labyrinth” wear ring.

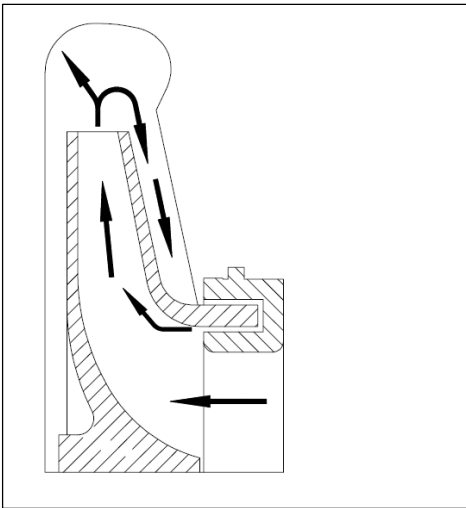
Wrap-Around Wear Rings

In the wrap-around design the wear ring extends into the eye of the impeller as well as fitting closely around the hub. With this design, water under discharge pressure in the volute tending to return to intake through the clearance between the wear ring and the impeller hub is forced to change direction and flow toward the impeller eye before it exits from the clearance; the leakage then flows with the water entering the impeller from intake.

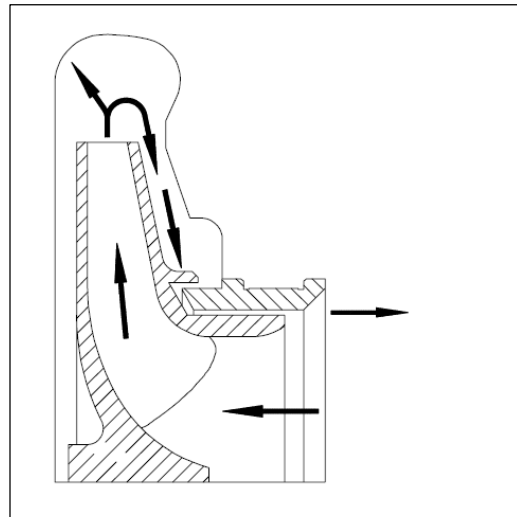
Labyrinth Wear Rings

In the labyrinth reverse flow design, the wear ring extends into an annular groove just outside the hub. With this design, water under discharge pressure in the volute tending to return to intake is first forced to flow back toward the impeller, then forced to change direction again and flow outward away from the impeller as it exits from the clearance; the leakage then flows against the water entering the impeller from intake. Tests made with both designs indicate that with the same amount of radial clearance, the labyrinth design allowed less leakage. With the original close clearance, a pump will have pretty much the same efficiency even with plain, simple, old style wear rings as with either the wrap-around or labyrinth designs, but with the same amount of excessive clearance, as will result from operation with sandy water, the wrap-around design is better than the plain, but the labyrinth design is best, by an appreciable amount. Of course, with reduced leakage the wear will be less, so the impeller life will be increased in two ways, it will take longer for a given amount of wear to occur and there will be less leakage when the wear is the same. And, of course, if the hubs are flame-plated, it will take much, much longer for a given amount of wear to take place.
